# Arlington House, The Robert E. Lee Memorial

## North Dependency Historic Structure Report

2010-0053-P

Report prepared by Charles Fisher, Chad Randl and Kaaren Staveteig

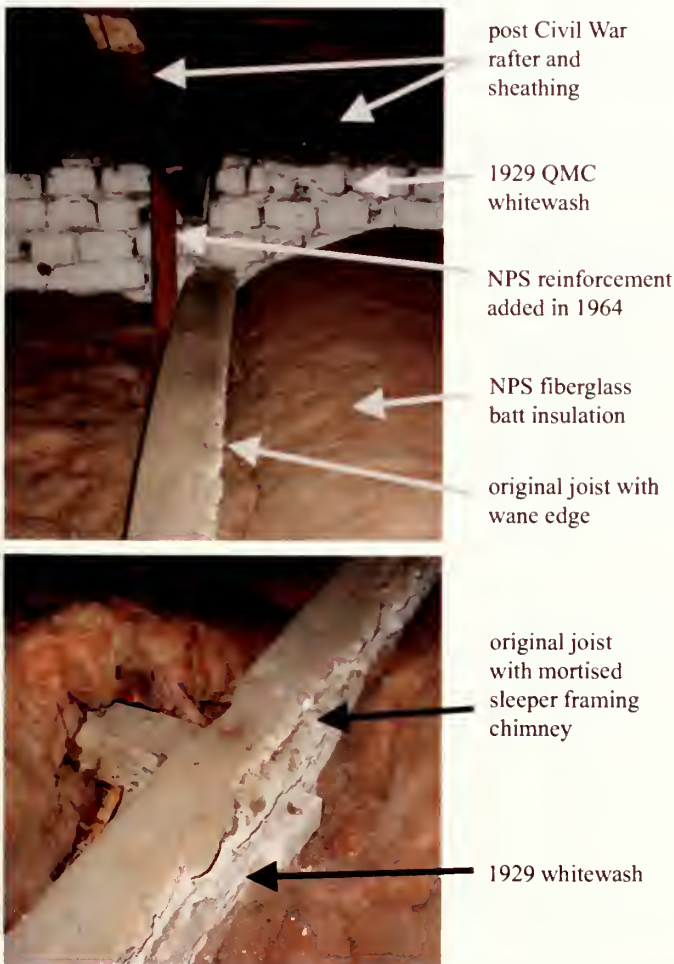
Figures 5 (top) and 6. Above east room, 2003. A surviving original joist with a wane edge, roughly finished and unpainted (until the 1929 QMC restoration). Original joists passed through or sat atop the north and south exterior walls to function as outriggers beneath the eaves.

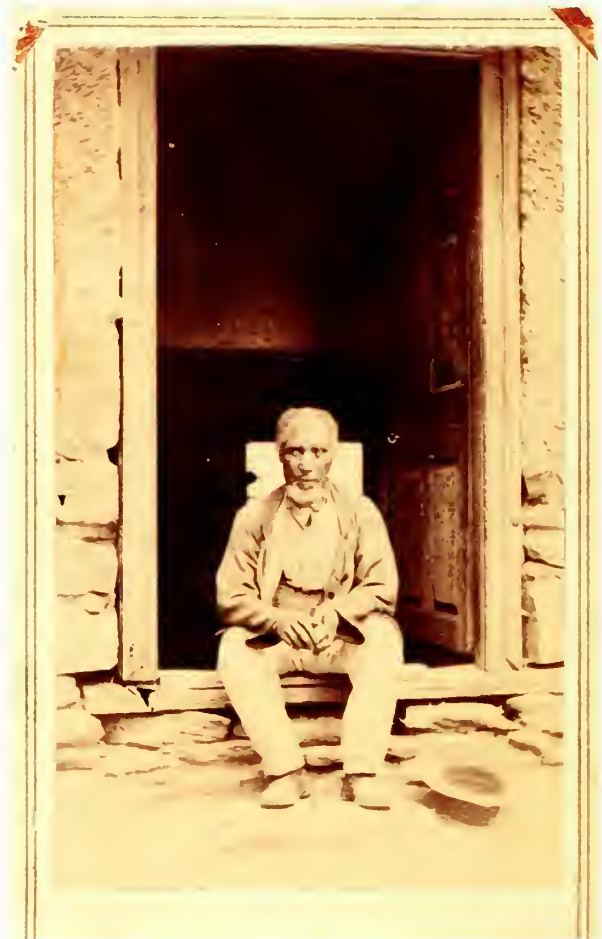
Figure 11. Doorway to east room, photograph of "Uncle Joe", circa 1864. The image shows the east summer kitchen window on the north wall directly behind Uncle Joe. (A muntin is visible just over his right shoulder.) The bulkhead that framed the entrance landing and boxed out the upper-level is also visible directly above and behind him. From Uncle Joe's position on the sill, it is clear that the landing within the doorway was lower than the height of the sill. This photograph also shows the 1860s era door and frame characteristics, and confirms the presence of the rough east stucco and exposed foundation exterior.

The photograph confirms the generally poor condition of the building at the time of the Civil War. Mortar around the stones framing the east doorway was deteriorated and there are sizable gaps between the wood door frame and the masonry finishes. As with the Russell photograph, the door threshold along the south elevation was located a noticeable distance above the then current grade level. While the sepia-tinted photograph is difficult to interpret,

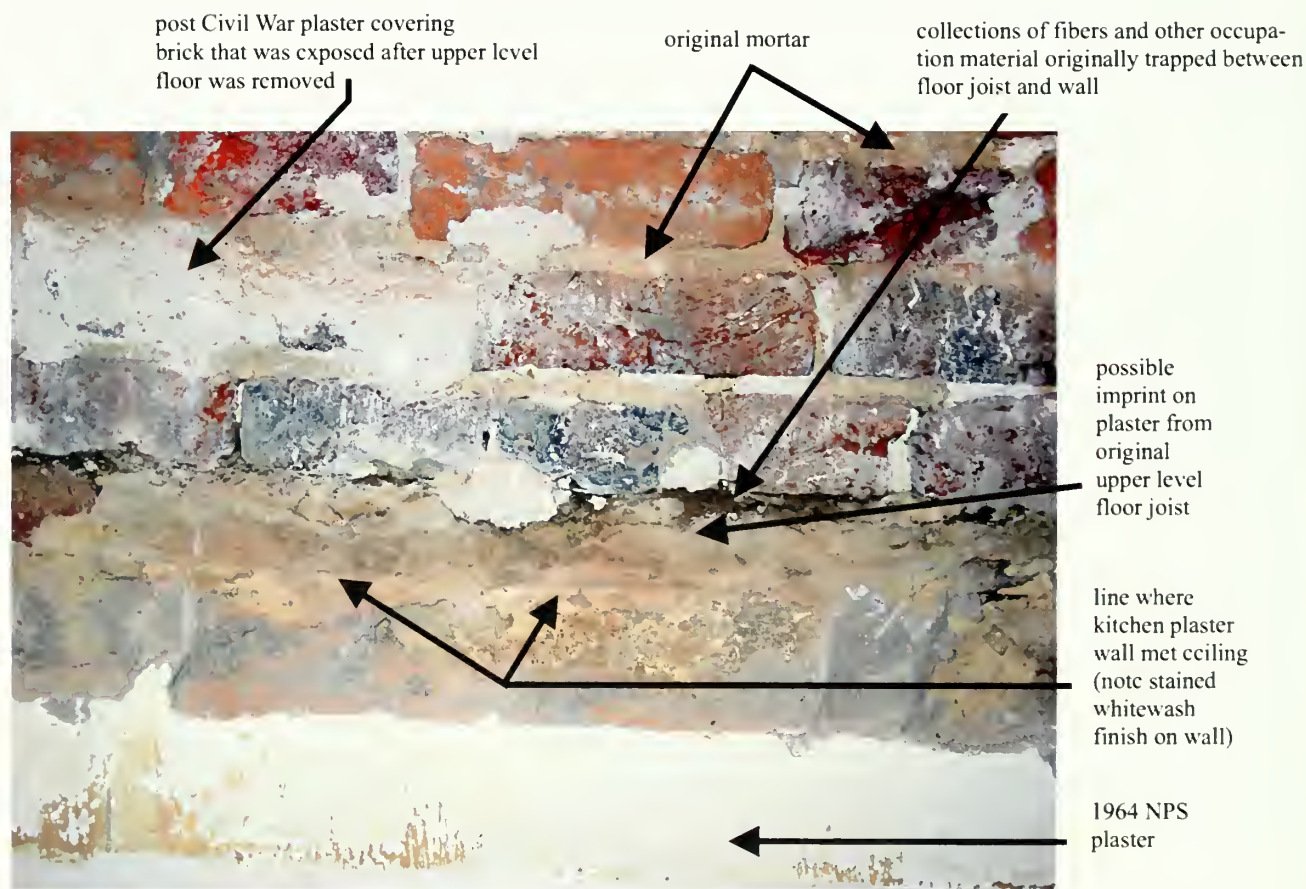
Figure 14. East room, west wall, 2003. Showing evidence of original floor level between upper living space and lower-level summer kitchen.

According to the plaster remnants on the west wall, the summer kitchen ceiling was positioned approximately 9'-3 7/8" above the historic floor level. As the lower edge of the plaster line on the north wall and the paint/nailers on the south wall are at the same level, it would initially appear that they mark the upper-level floor line. However, placing the floor at a level that lines up with the plaster line on the north wall cuts across the baseboard nailing blocks on the south wall. Neither baseboard nailers nor the paint and plaster found on the south wall would be found below the floor line (hidden beneath the floor and abutting the floor joists). Instead, these elements would have been above the floor line. If 5", the height of a typical early nineteenth century baseboard is subtracted from the line corresponding to the nailing blocks and north wall plaster line, the upper-level floor height would be approximately 10'-7/8" above the historic floor. Therefore, the space between the established lower-level ceiling and the upper-level floor is approximately 9". This height could have accommodated joists with lath and plaster below and floor boards above. See *Appendix I: Period and Rehabilitation Drawings* for further description of the historic configuration.

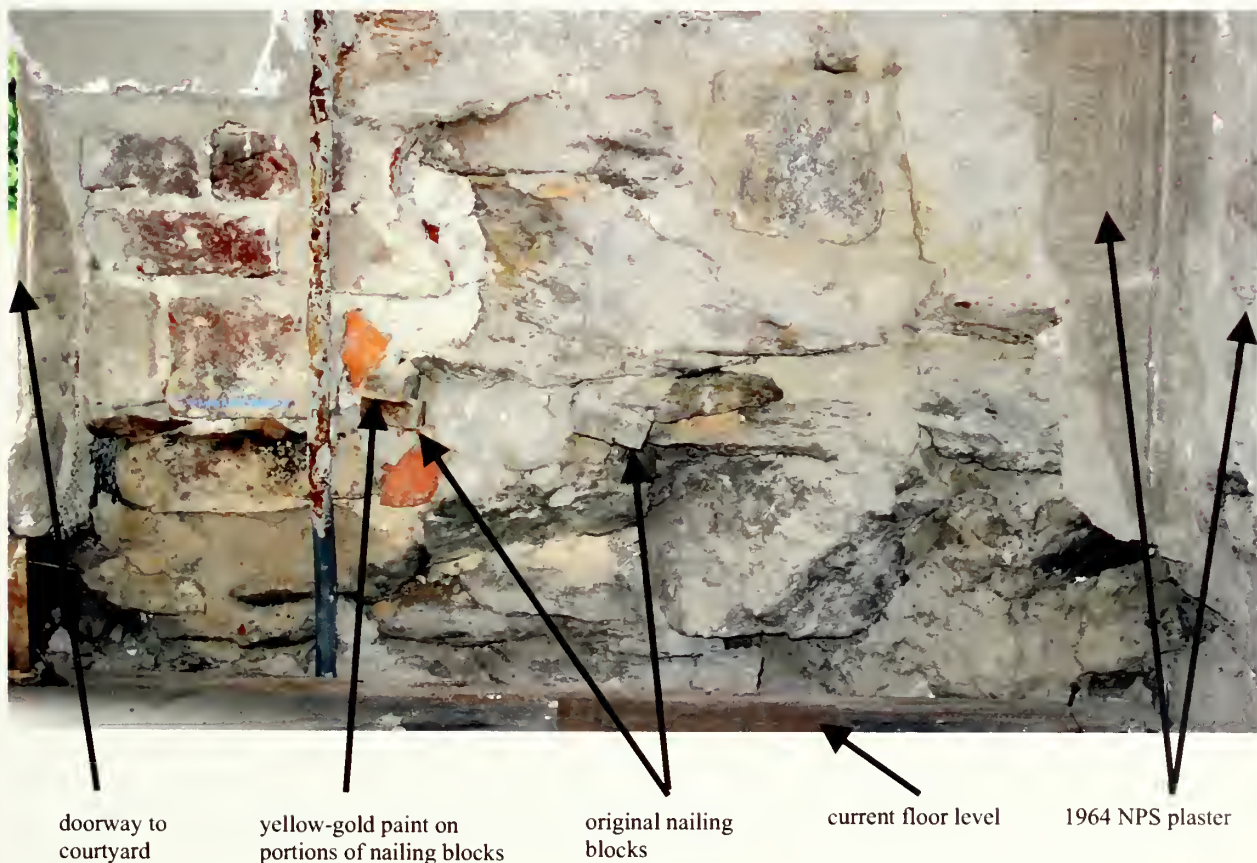
Figure 20. Center room, close up of west side of south wall, 2003. Showing nailers embedded in original plaster.

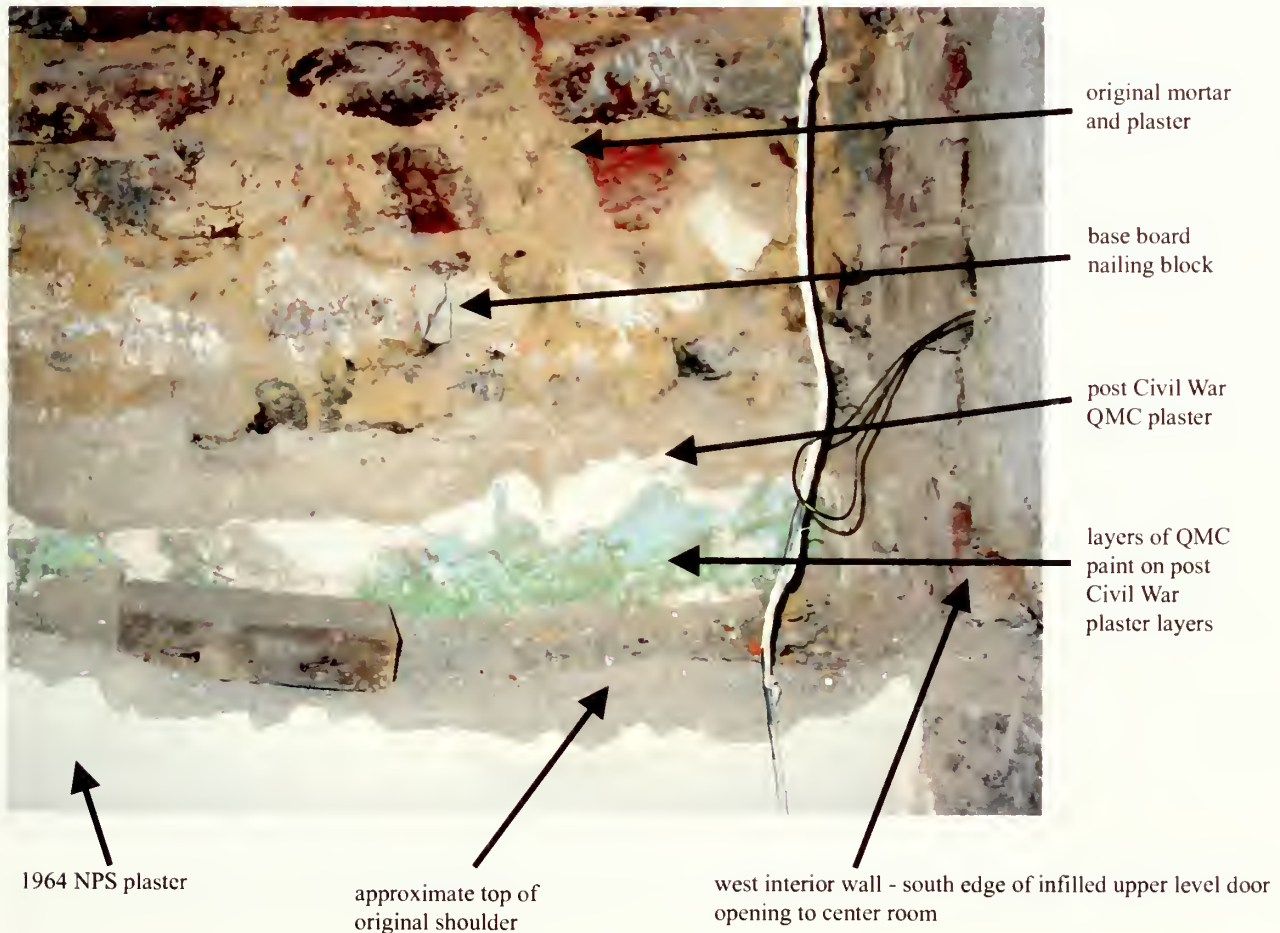
Figure 22. East room, west corner of south wall. After the Civil War, the QMC converted the east and west rooms to single level spaces by removing the upper-level floor and installing a new floor at-grade. This alteration revealed several courses of bare brick that the QMC then plastered over. Remnants of this plaster are visible on all four interior walls. Layers of paint finish survived on the north and south walls behind several courses of brick that the QMC had laid atop the original shoulder to raise the shoulder height during the 1930 restoration. The photo shows the shoulder with these later bricks removed to reveal the post Civil War plaster beneath.

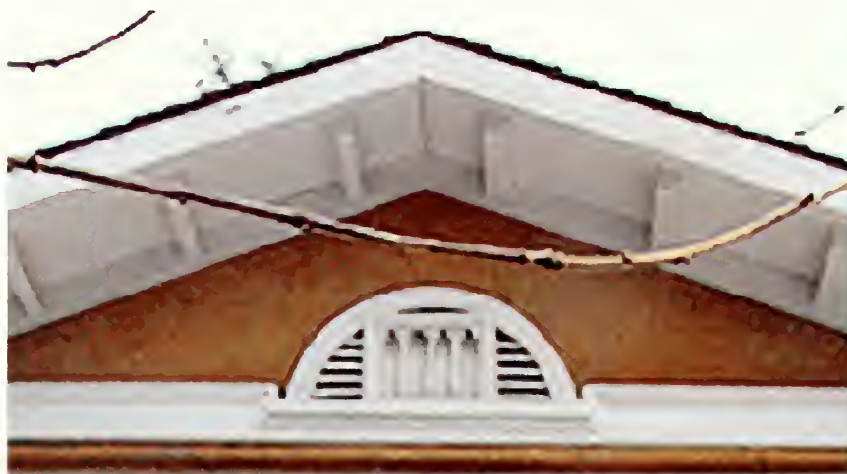
Figure 19. West elevation, fascia board is deteriorated.

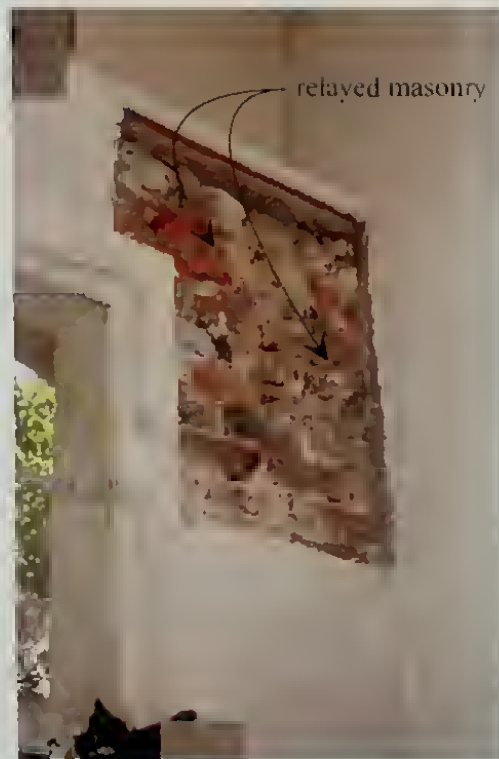
North Dependency, Center Room: The north elevation contains evidence of a large repair or possibly the addition of the exterior arch and window. Distemper finishes found in the undisturbed lower area of the wall suggest that this room had a similar paint history as the upper east room. The general location of the floor level is indicated by a gradual reduction in the plaster thickness. The floor line is not as distinguished as that documented in the east room, but this is due to the quality of the surviving evidence.
